Thornton Benchmarking Analysis

Commercial, Industrial, and Institutional Indoor Water Use

CASE STUDY: THORNTON CITY BUILDINGS

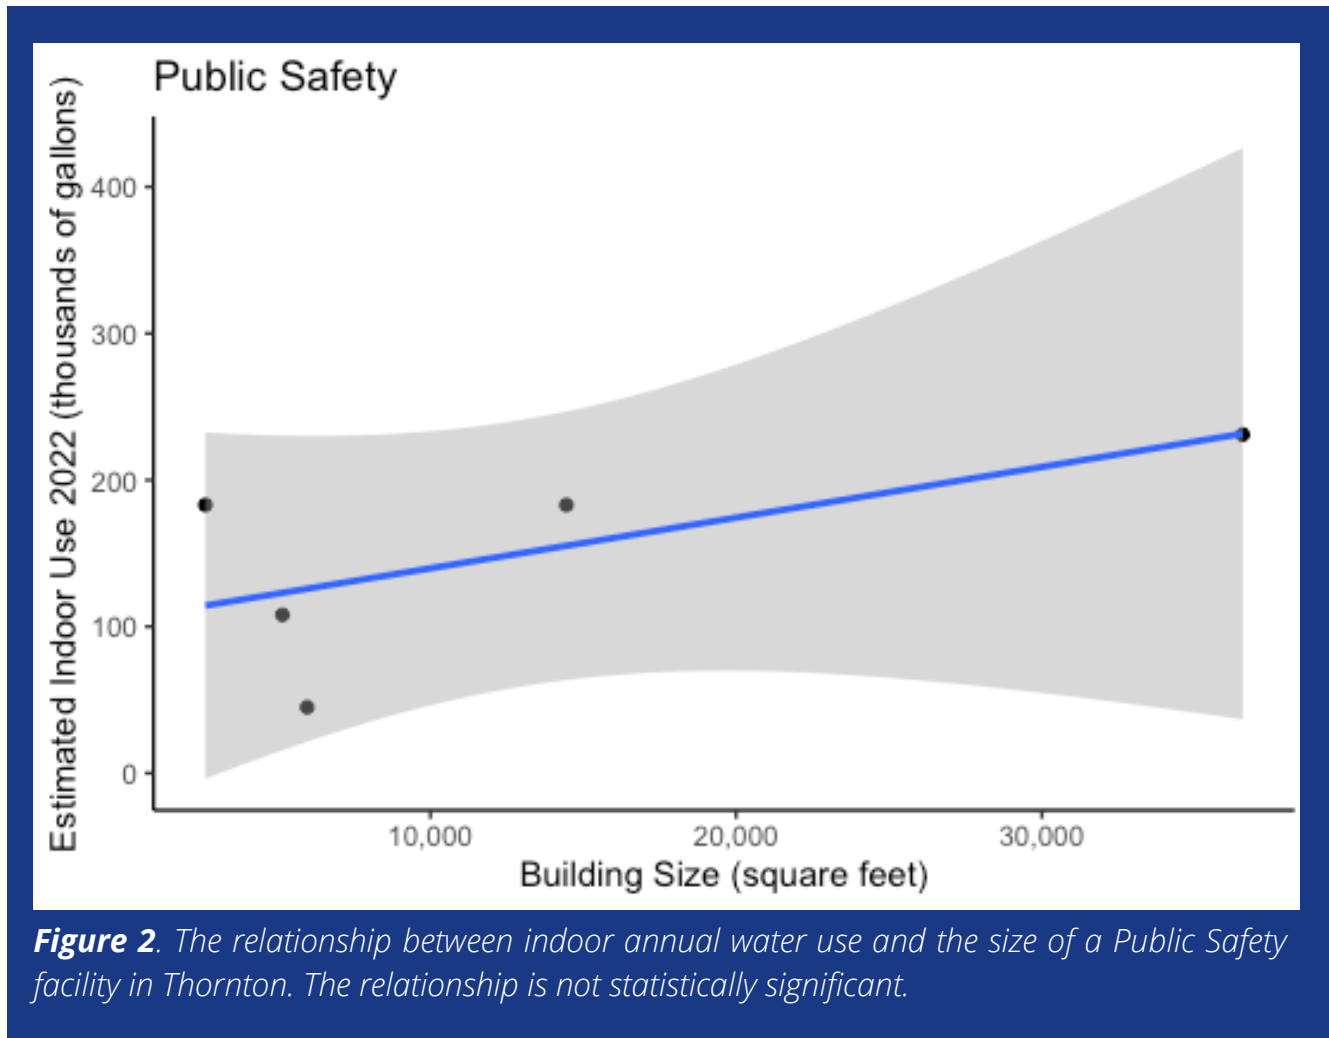
Public Safety buildings showed no statistically significant relationship between building size and water use, with a relatively flat distribution of total water use across all six fire stations for which data was available (**Figure 2**). They compared moderately in terms of normalized use across all commercial, industrial, institutional and multifamily residential users, ranking 12th out of 21 categories, with a median use rate of 12.7 gallons per square foot per year. These buildings used an estimated 20% of their annual water consumption indoors, making them a potential target for indoor conservation practices, but potentially standing to benefit more from outdoor conservation approaches.

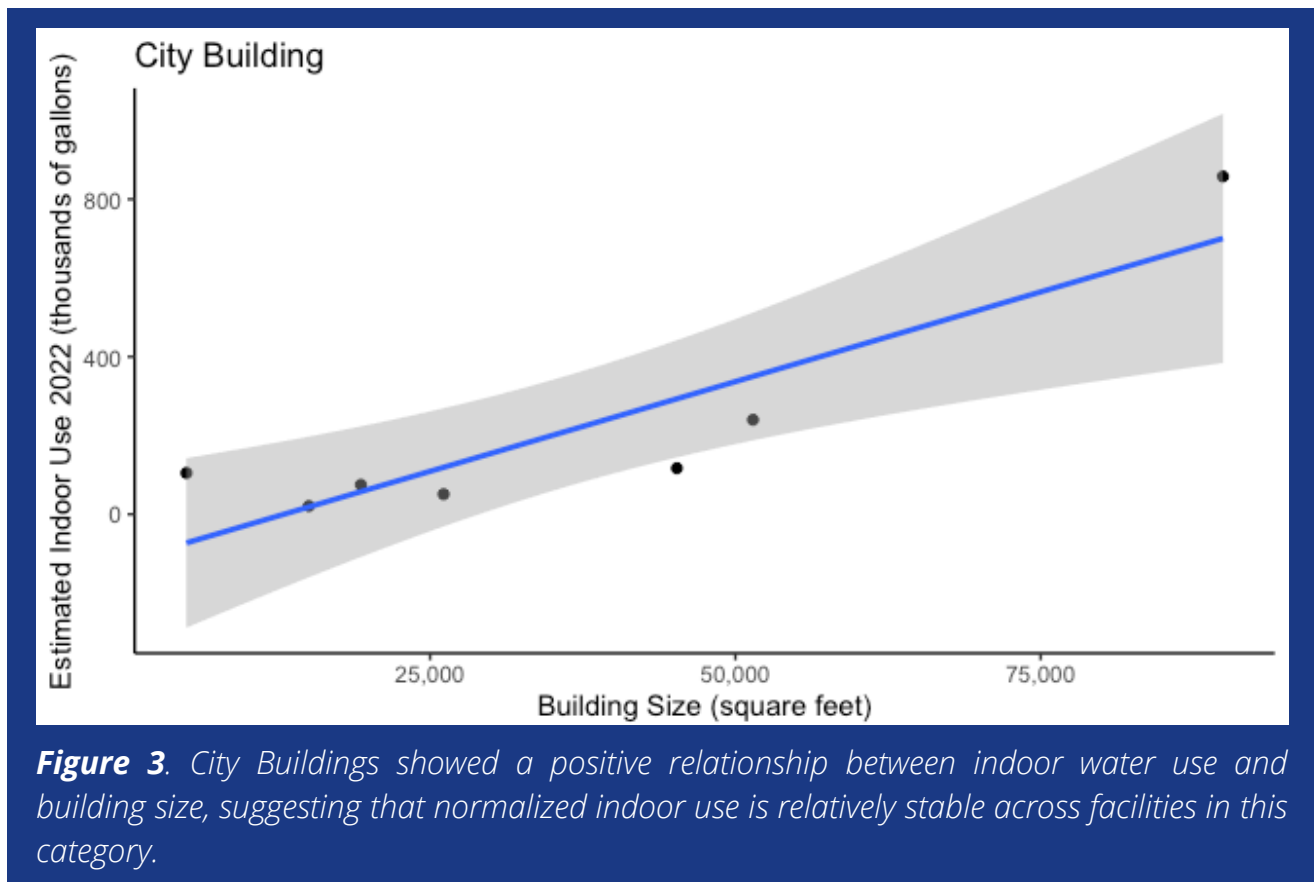
City Buildings demonstrated a relatively strong relationship between building size and water use, suggesting that water use per square foot is relatively stable across municipal buildings with administrative and community-centered roles (**Figure 3**). The median City Building used 3.9 gallons per square foot of indoor space per year. High users in this category used 7.1 or more gallons per square foot per year, while low users used 2.3 gallons per square foot per year or less. This reflects the second lowest rate of indoor use across the 21 categories we examined, making City Buildings a very low-using category within the broader landscape of commercial, industrial and institutional water users in Thornton. Like the other city facility categories, a majority (86%) of water use at these facilities occurred outdoors over the course of the year, suggesting that outdoor conservation strategies should be employed alongside the indoor water conservation approaches focused on in this study.
